## **HOSPITAL FIRE**

St. Jerome, Quebec Canada January 29, 1989

## **Summary Investigation Report**

# Thomas J. Klem Director Fire Investigations Division

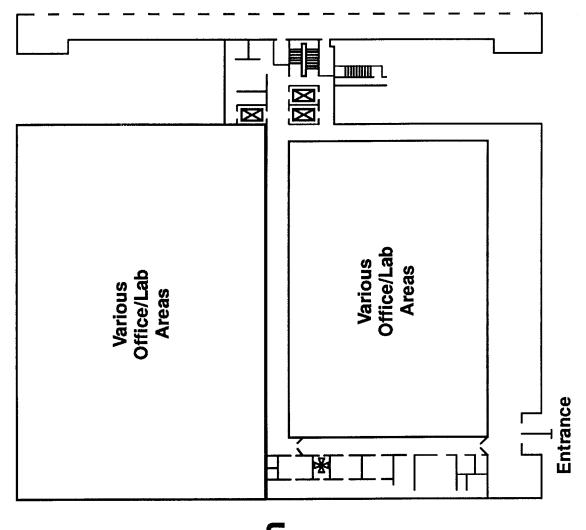
Figure 2 Emergency Room Floor Plan

The fire originated in an isolation room approximately 150 feet from the emergency room entrance along the north-south corridor. Access to the 8 X 10-foot room was gained not only from the public corridor side but also from a nurses' (medical staff) area. The nurses' area was positioned parallel to the public corridor with several observation rooms sandwiched between the areas. This arrangement enabled the medical staff to move along a rear corridor and into treatment rooms for care. The medical area contained medical treatment materials and supplies stored in wooden cabinets or placed on counter space.

Fire damage to the emergency room area was extensive. The fire consumed most of the combustibles in the room of origin and spread to several adjacent observation rooms, also causing extensive damage. Since the doors to the room of fire origin were open, the medical area and the exit corridor also were severely damaged. The north-south corridor had extensive damage along its entire length, as did approximately half of the east-west corridor. Closed smoke doors at the north end on the north-south corridor were effective in preventing fire spread in this direction. Combustibles in the corridor area (mostly mattresses on stretchers totally

Smoke spread in the emergency room area followed a path similar to the fire spread. However, there was some smoke spread into adjacent functional areas, most likely around doors that were closed and by way of HVAC systems open ducts. Smoke was able to move freely through over 400 feet of the exit corridor to the elevator lobby because a smoke barrier door (adjacent to the room of origin) was blocked open. Other smoke barrier doors in the area were closed and were effective.
